1965 Gibson GA-45RVT Saturn Amp

Mark Herrmann

Physics 398 EMI
Fall 2002

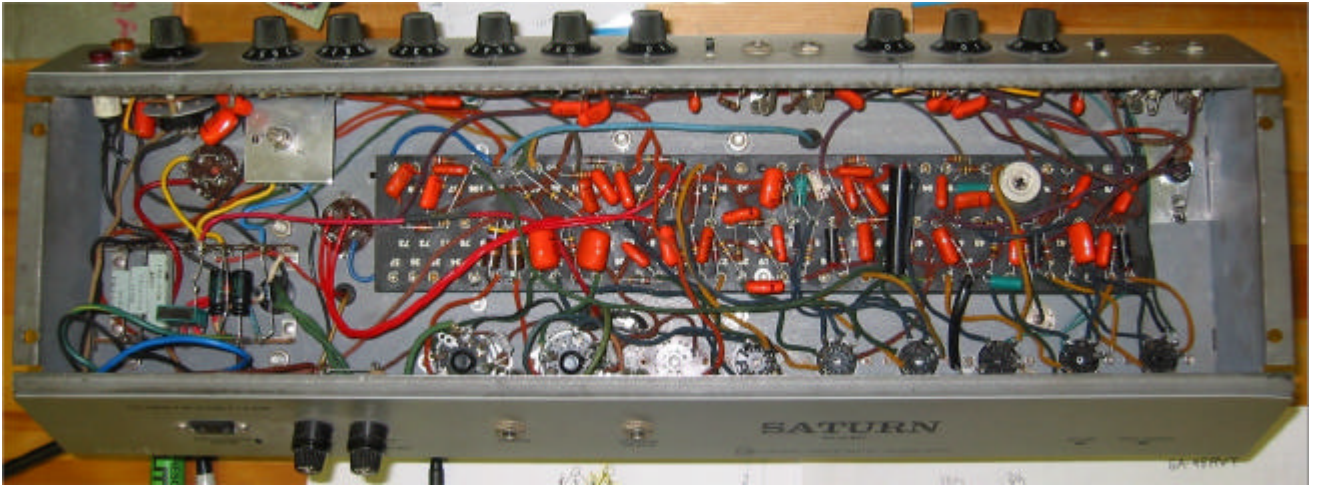
Figure 7 – Amp Chassis before removing Twin-T filters and replacing capacitors

Note in figures 7 and 8 where I installed the electrolytic can capacitors, which appear as brown circles on the left side of the pictures. On the far right is the metal plate I installed to hold the new footswitch connector. Note also the 10k ohm bias pot I installed on the left side as well as the gray 1-ohm resistors on the power tubes. By comparing figures 7

and 8, one can see all the extra circuitry that I removed due to the Twin-T filters, as well as the new higher valued capacitors I installed, which are black.

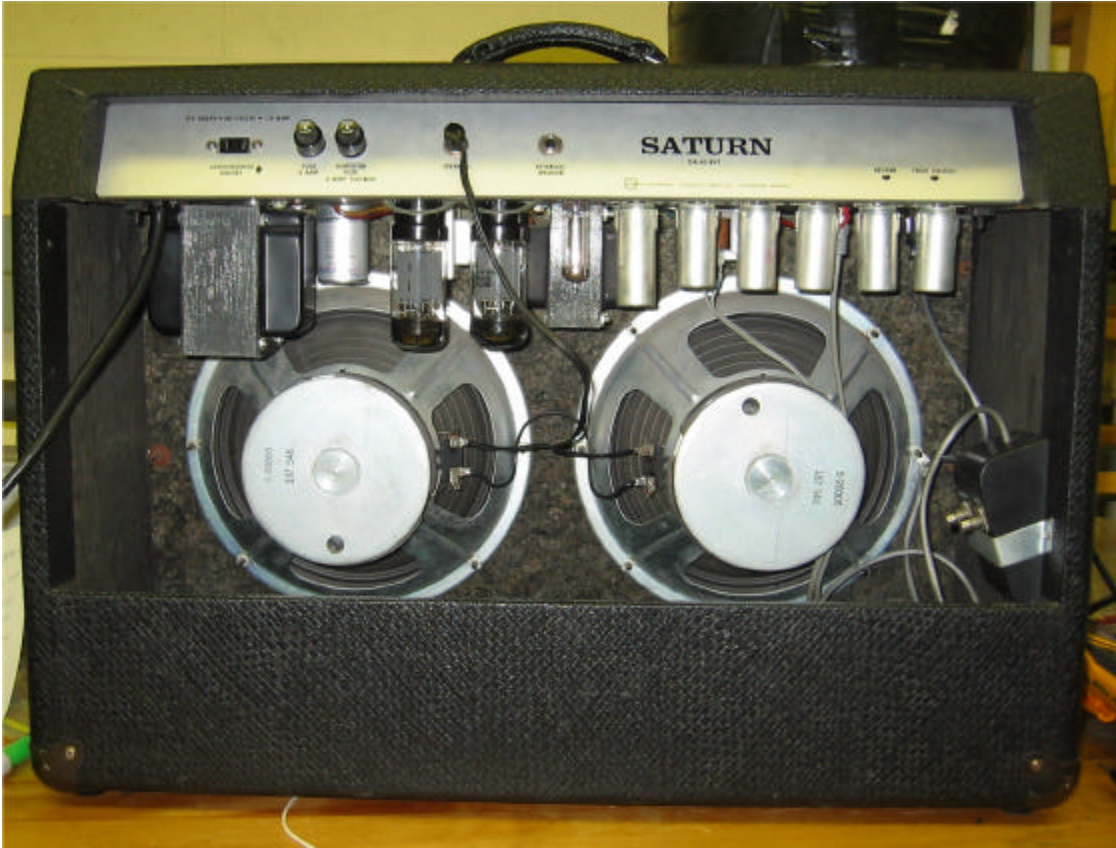
Figure 9 – Rear view of Gibson Saturn after completion of repairs and modifications

Note in figure 9 the electrolytic can capacitor I installed that is hanging down just to the right of the transformer on the left side of the amp. There is another one behind the transformer that cannot be seen in the picture.
