Fixing/Rebuilding a Rickenbacker M-10

James Milsk
Physics 498
May 9, 2005
Professor Errede

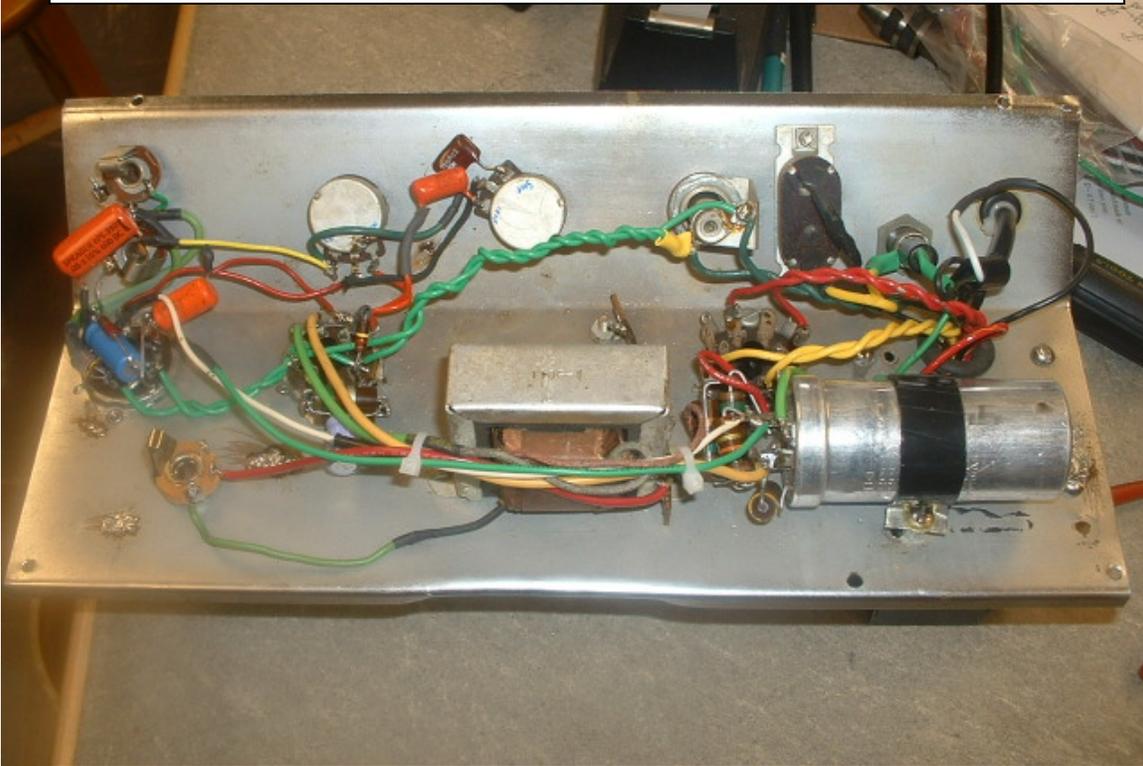
Fig. 4 “Top view” of the chassis. All point-to-point wiring is used.

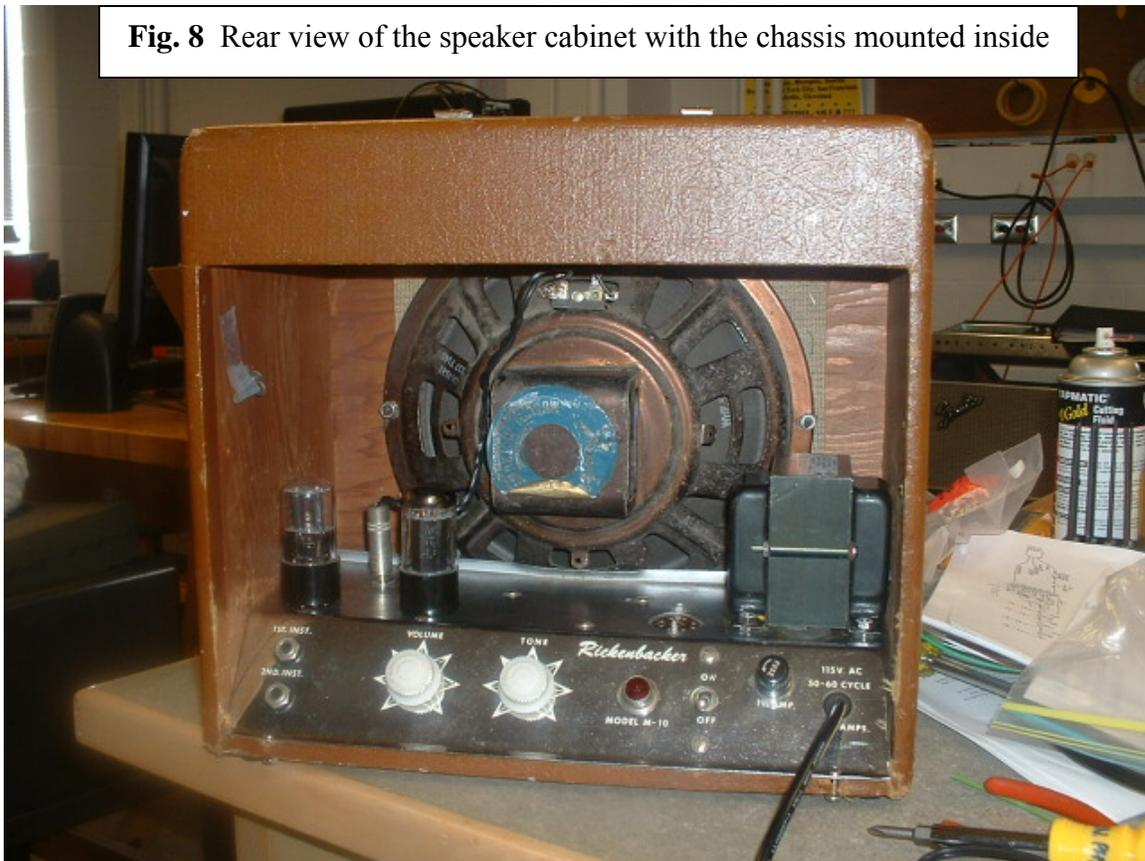
Fig. 8 Rear view of the speaker cabinet with the chassis mounted inside
