Tuning a Fender Twin Reverb

Lee Feder
Physics 498 POM
Professor Steve Errede
12 May 2005

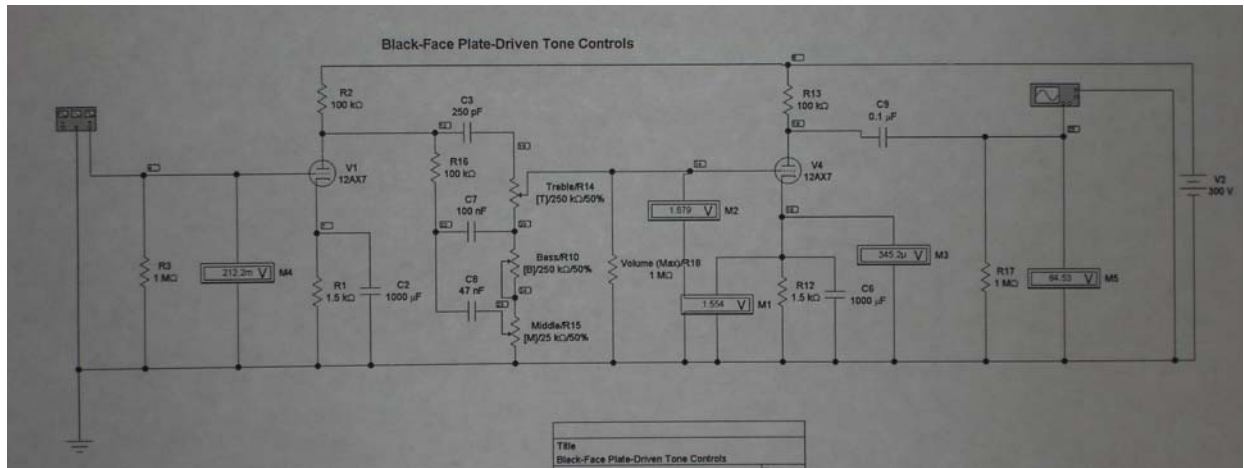
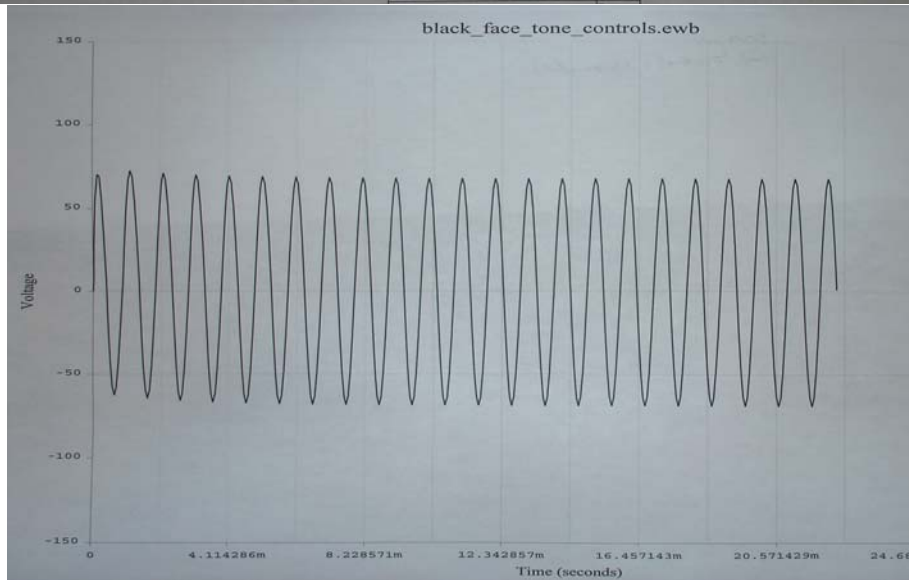
The utility of the extra gain can easily be seen in the schematics and graphs on the following pages. The first set (Figure 4) shows the functioning of the preamp stage as Leo Fender designed it: the capacitor (here it is $1000\mu\text{F}$ to enhance the effects on the graphs but on the amp is really $25\mu\text{F}$) is wired in parallel with the 1.5K resistor (In the amp this is 820K because there are two preamp tubes forcing current through the resistor and since Ohm’s Law $V=IR$ is linear, if there is twice the current the resistance should decrease by a factor of 2 in order to keep the voltage drop constant; $820 \sim 1/2 * 1500 = 750$. These numerical changes do not alter the effect, but only obviate it for the sake of argument and demonstration.). The gain of V4, the preamp tube in question, according to the original design is a hefty gain of $84.53/1.679 \approx 50$. The ratio compares the input voltage on the grid to the final output voltage; both are root mean square alternating current voltages ($V_{\text{AC}}^{\text{RMS}}$). As the Voltage v. Time graph shows, there is moderate clipping on the upper part of the sine wave. Instead of rounding off evenly or even coming to a moderate point, the top of each wave crest is chopped off and even has some visible transients. This, were we to subject it to Fourier analysis, would show the addition of harmonics not present in the original pure 1 kHz sinusoidal input wave coming off the simulate function generator. Finally, the Voltage v. Frequency graph shows a rapid drop off as frequency increases. While most of this occurs well beyond the audible range, it nonetheless happens and serves as a point of comparison.

Additionally, because the capacitor is no longer connected, the high frequencies have a greater presence, brightening up the sound. The bottom graph in Figure 5 shows that not only do the ultra high frequencies not drop off as quickly as in Figure 4's graph, but the lower frequencies have less gain as well. In the real amplifier, this effect would migrate down to the more audible range. Since the resistor and capacitor basically form a high pass filter to ground, the capacitor in Figure 4 permits all the high frequencies to escape from the signal path while retaining the lower ones. Since the capacitor modeled here is 40 times that of the real one, the RC constant for the filter will be 40 times what it is in the real amplifier.

movement of the cathode increases the range in which the grid can travel from its steady state potential before clipping occurs. As seen in Figures 4 and 6, slight clipping occurs. Since the voltage into the grid as well as the voltage across the capacitor are AC and therefore RMS measurements, they must be converted by multiplying by a factor of $\sqrt{2}$. Thus, the threshold for the cathode in Figure 4 is $\sqrt{2} * 345.2 \mu\text{V} + 1.554 \text{ V} = 1.554 \text{ V}$. Since this voltage is below the grid voltage of $1.679 * \sqrt{2} = 2.37 \text{ V}$ the signal is cut off because the grid potential exceeds that of the cathode, that of the resistor plus that of the AC voltage drop across the capacitor, at the top of each signal crest. At this point the grid effectively turns around the electrons escaping from the cathode, thus preventing the signal from reaching the plate and continuing. In Figure 6, the numbers are similar, but as the graph of voltage versus time shows the clipping is barely present: $\sqrt{2} * 1.169 + 1.55 = 2.63 \text{ V}$. The grid voltage is $1.857 * \sqrt{2} = 2.63$. This comparison manifests one of the most appreciated property of tubes: instead of cutting off sharply as transistors do, the peak more "softly." Figure 6 shows that even though the grid at best matches the cathode voltage, there is still a tiny bit of clipping, which may be desirable, depending on the listener. Both of these calculations contrast sharply with those from Figure 5. The total cathode voltage is $\sqrt{2} * .8016 + 1.534 = 2.67 \text{ V}$ while the total grid voltage is $\sqrt{2} * 1.697 = 2.40 \text{ V}$. Here the grid is safely below the cathode at all times and so the tube does not clip or distort significantly enough to show up on the graph.

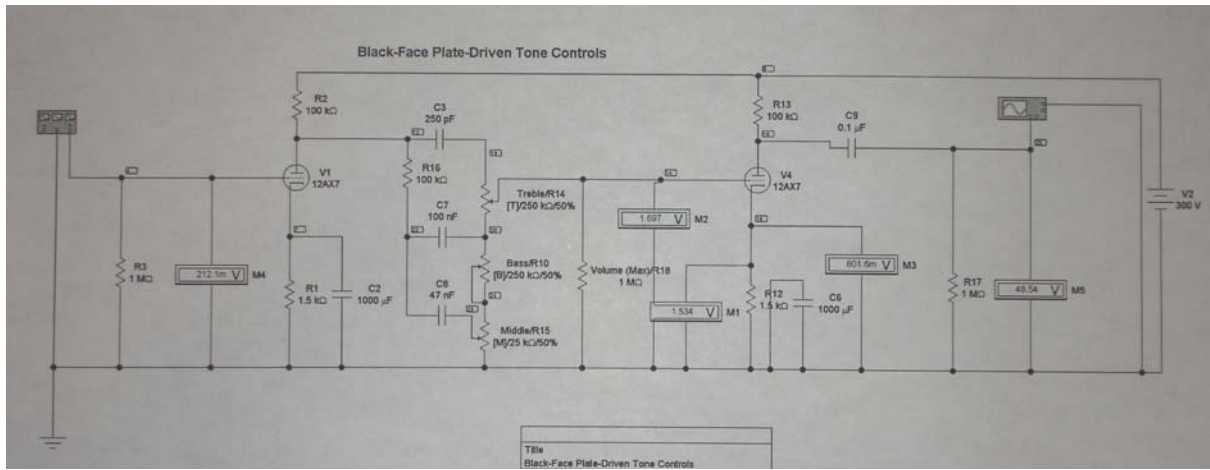
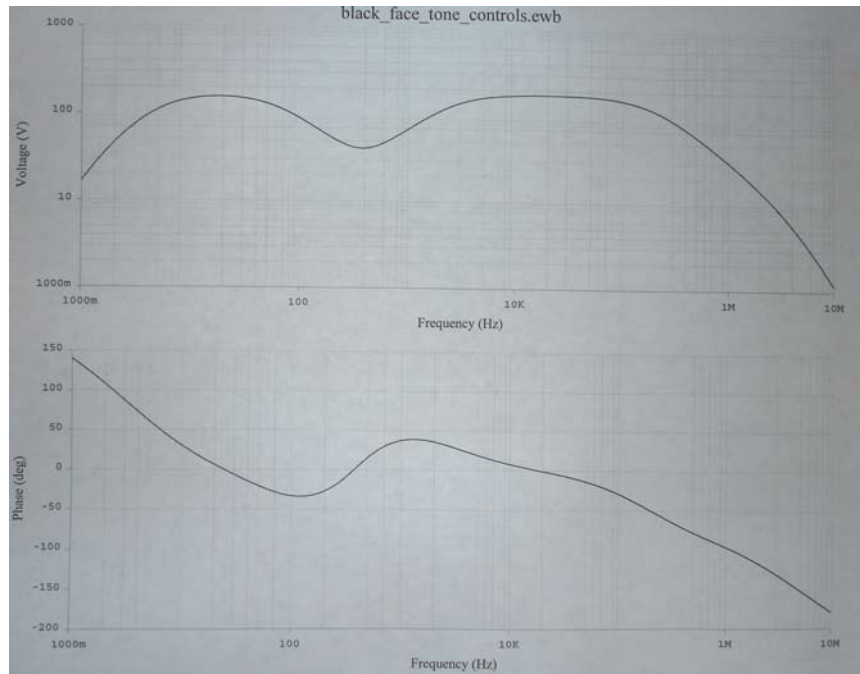
Figure 5 shows the amp under normal operation with the volume control set at the same level, with the same input signal, but with the switch effectively pulled out. In this case the capacitor is disengaged and so has no bearing on the input signal. As a result, the gain is significantly decreased. Here the gain is $48.54/1.667 \approx 30$, using the same computation as before. As a result, there is no clipping; the first graph shows a balanced sinusoidal curve with no chopped crests or troughs and no transients.

The difference between Figures 5 and 6 has to do with the input signal strength. In both 4 and 5 the input signal was 300 mV whereas in 6 the input signal is 50% more, 450 mV. In both 5 and 6, the capacitor is effectively removed; since this reduces the gain of the stage, the tube effectively has more "head room" to accommodate a stronger signal. As shown in the V vs. T graph, there is moderate clipping with this stronger input despite the disconnected capacitor. While the gain is still less than with the capacitor ($70.77/2.534 \approx 27$), the amp can still distort. This fact emphasizes that, for instance, a guitar player could suddenly switch from a mellow to hard playing style and, if the switch is pushed in, the amp would not distort terribly, but rather would accommodate the increased signal strength (i.e. turning up the volume on a guitar). There would only be the limited distortion manifest in a lower strength signal in Figure 4. Additionally, this configuration features the stronger top end, giving the amp a brighter sound.

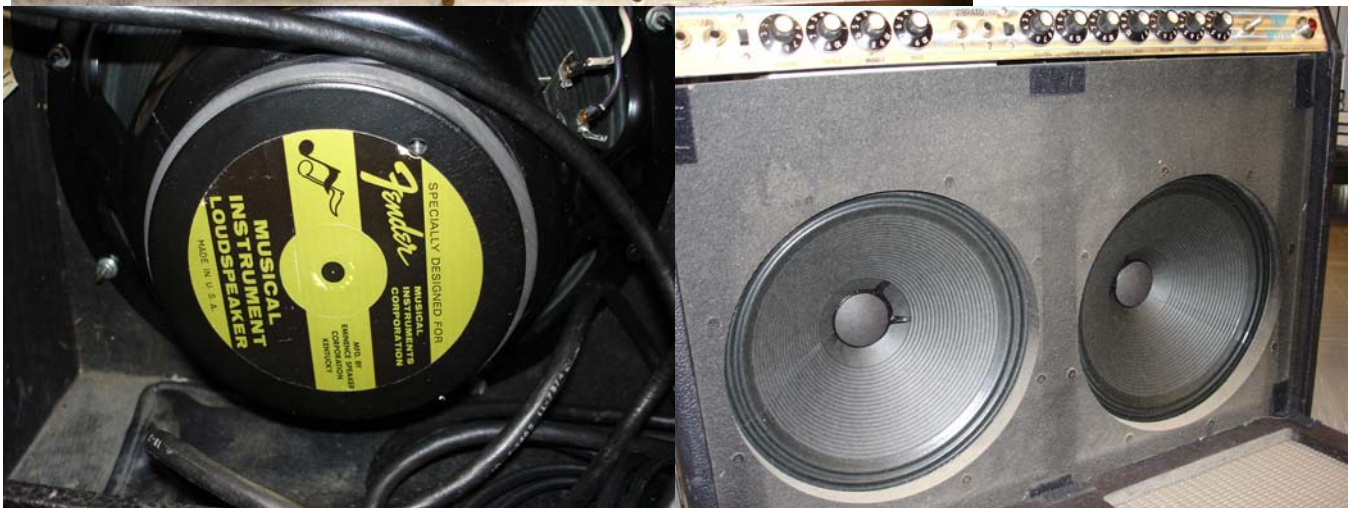
Below: Pictures of the replacement 1997 Eminence speakers. Compare the magnet and voice coil with those

The first conclusion Professor Errede made was that the speakers in the cabinet were of “low quality,” to put it nicely. After investigating, it turned out that the speakers were some of, if not the, worst Fender ever shipped with an amp. As soon as possible we pulled the speakers from the cabinet and replaced them with a pair of Eminence speakers from the Professor. While not top-of-the-line speakers, these still represented a major improvement. Installing them proved easy, once the old speakers, the glue attaching the gasket to the baffle board, and the torn gasket were all scraped clean and made level. Without this painstaking attention to detail, the speakers will not seat properly on the baffle board and could be damaged during playing. Once installed, we retested the amp and found major improvements in the high and low end clarity. While some distortion at maximum volume remained in the bass region, the tone sounded much more clean and listeners could finally hear the “clean Fender tone” that my brother felt had disappeared from the amp. The new speakers, which featured a large voice coil and magnet to improve frequency response, combined with soldered connections between the plug and two sets of speaker terminals, replaced what had clearly been the weakest link in the chain (see pictures, Appendix 1).

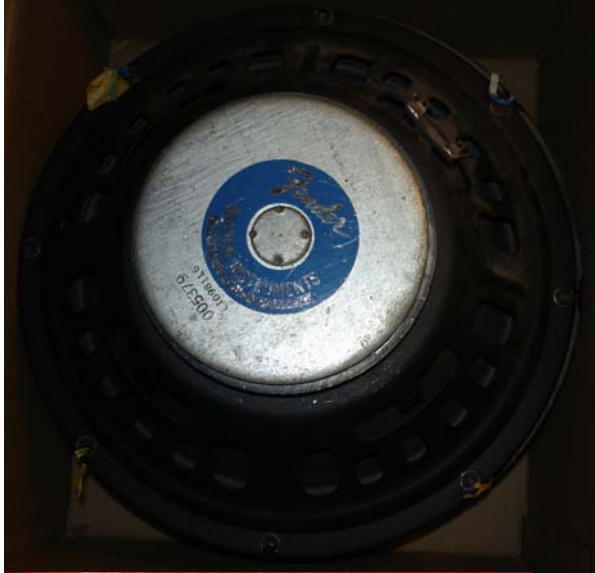
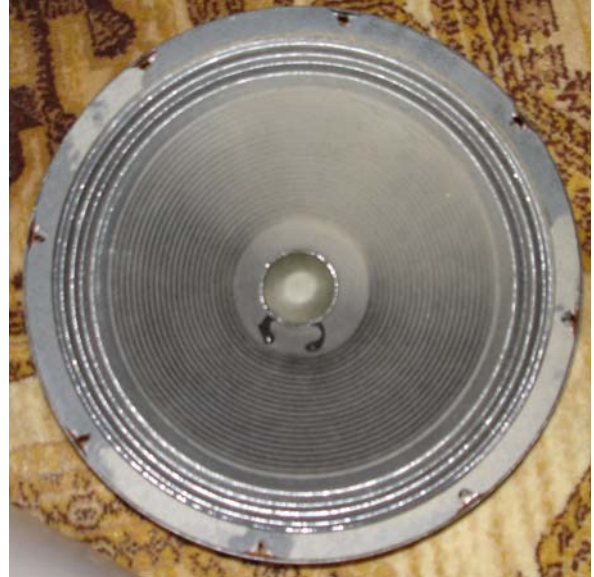
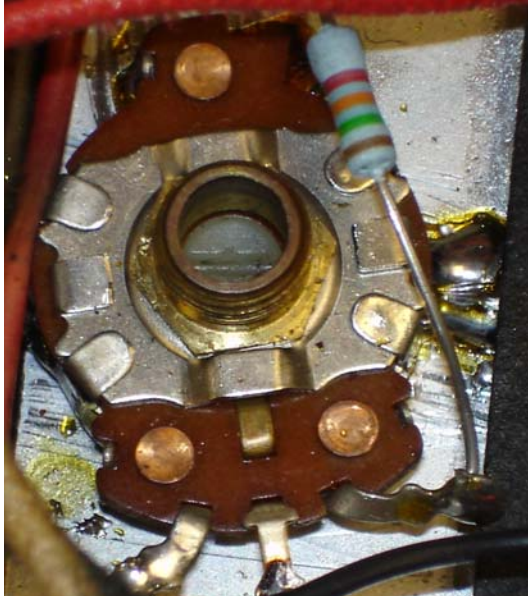
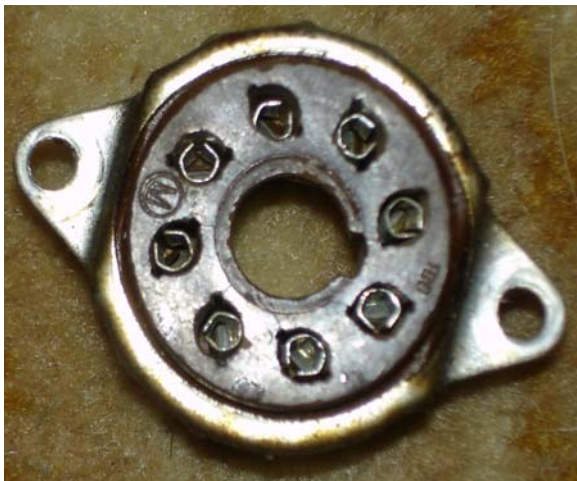
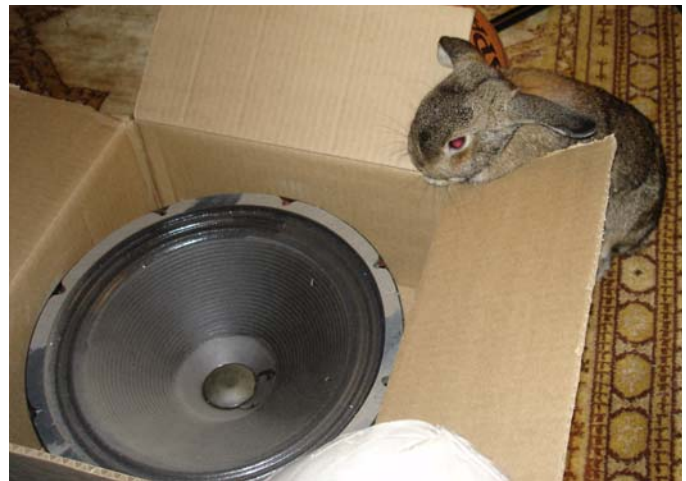
Counter-clockwise from top right: Notice the smaller voice coil in the original speakers; the smaller magnet on the original Fender speakers; the biasing pot; the damaged pins on one of the old power tube sockets-look closely for corrosion and signs of abuse; a curious fellow performs an investigation of his own.

Perhaps the most important change we made involved the tube sockets. At the end of the semester we were preparing to compare the backup set of Svetlana 6L6GC power tubes with the already-installed Sovteks. However, as soon as we switched the tubes, there was a moderately loud hum. The hum remained even when we replaced the tubes with the original Sovteks. It seemed to be 60 Hz noise, so we switched off the amp to investigate for blown capacitors or resistors. Were one of the electrolytic capacitors to pop, the amount of ripple traveling throughout the amplifier circuit would greatly increase. The capacitors, combined with the diodes and choke, work to limit the oscillations of the wall power, so this was a logical first step. However, no resistors, capacitors, or tubes appeared to have burned out. After several frantic measurements, Professor Errede discovered that the pin sockets on the power tubes were unconscionably corroded (see pictures, Appendix 1). While one of the tube sockets had clearly been replaced last June by Ben Juday, the others were still original and looked as though someone had kept the amp in a high-humidity environment. Despite over an hour of cleaning, it became obvious that for both safety and performance reasons, the sockets would have to be replaced. Unfortunately, this was not something I could do since it required several intricate solders in tight space. Many thanks to Professor Errede for performing this painful fix. With new tube sockets and the Sovtek 6L6GC's rebiased, the amp sounded slightly cleaner, with no hum, and performed much louder as well. The final biasing data are shown in Table 6.

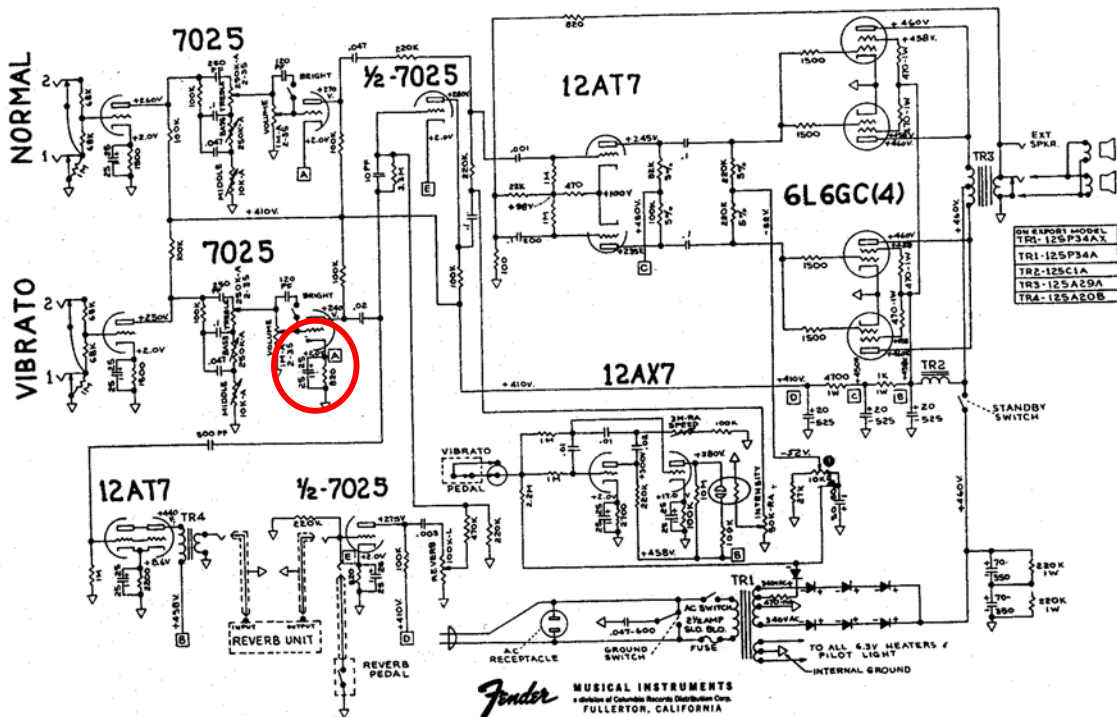
Above: The original schematic from CBS. Below: The much simpler and much more relevant 1963 "Black Face" schematic. The area circled contains the components
