**Modified 5E3 Deluxe Guitar Amplifier**

ECE 445, SENIOR DESIGN PROJECT  
& Physics 497 Independent Study Project  
FALL 2004

Project No. 29

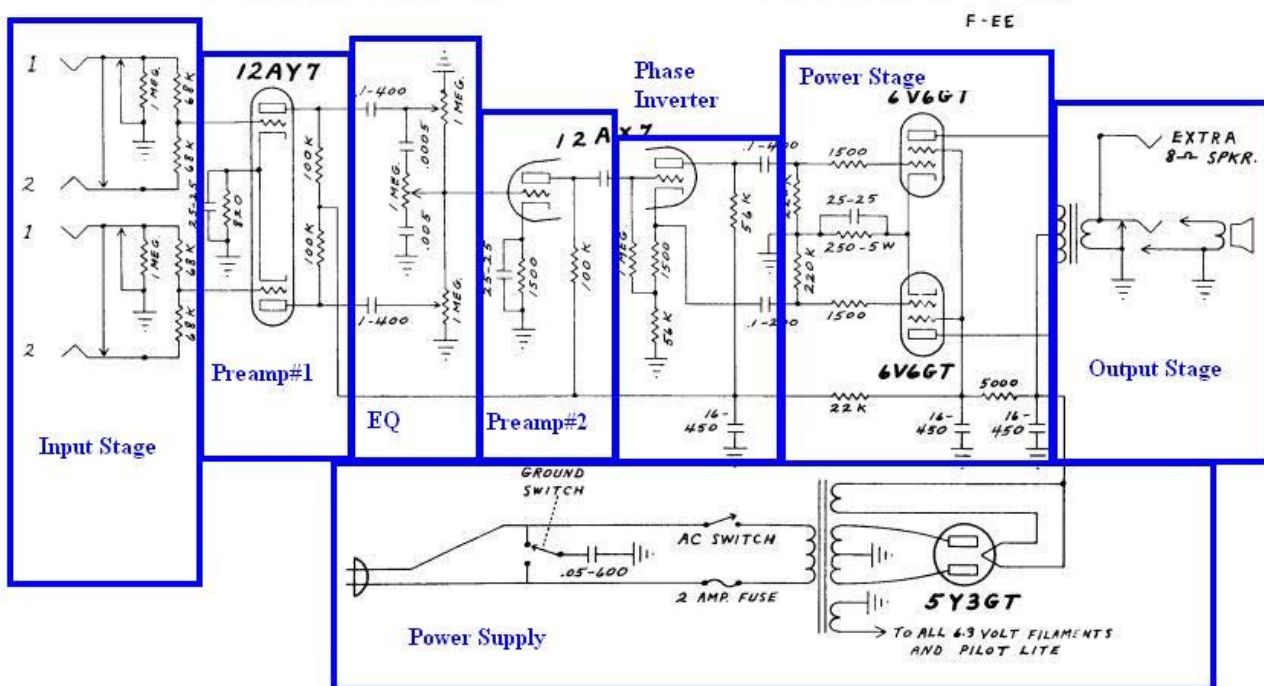
Fig. 1 Original Circuit with outlined stages

Figure 1 shows the original Fender schematic with each of the circuit stages boxed off. Below is a brief description of the function of each stage.

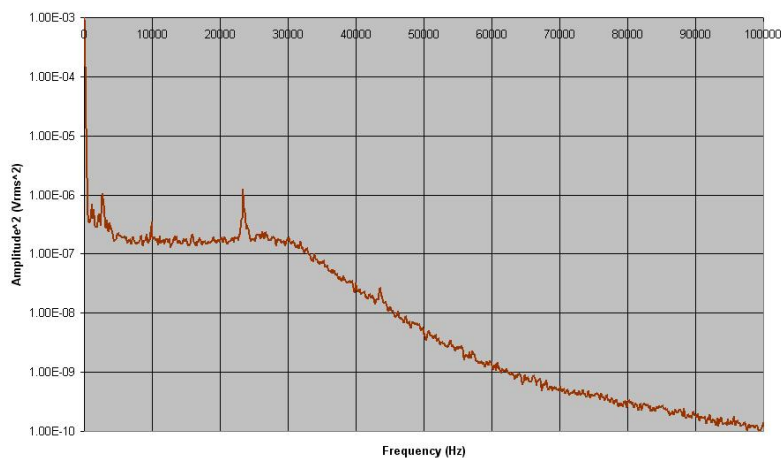
**Fig. 2.3** Noise Floor of Original Amp

Figure 2.3 shows the original amplifier’s Noise Floor, which is the amount of noise present at the speaker without applying an input to the speaker. This means that whatever voltage is appearing is due to the noise in the circuit alone. The spikes

present are at 3.5kHz, 24kHz, and 44kHz are most likely due to the ambient noise in the room where the measurements were made – from PCs, LAN/Ethernet, and other electronic devices. This is represented by the Fourier Transform on a 1-100,000Hz scale.

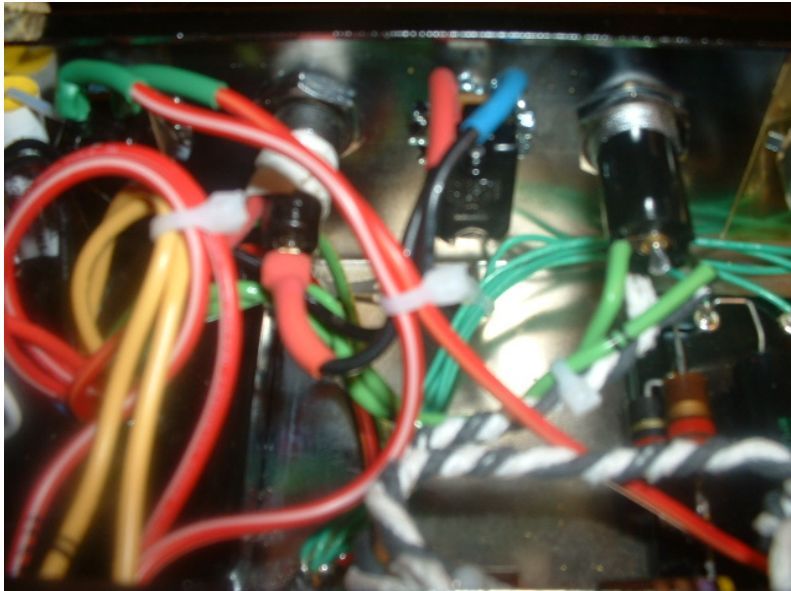
**Fig. 2.4** Inner detail of circuit –star ground and filament conductors

properly, then wires attached to star ground simply maintain earth potential on the distributed star ground “network” – only very tiny transient currents flow in doing this. We used a method called distributed star grounding. We used a bent metal washer sandwiched between the power transformer and the chassis as the primary star ground point (seen at the bottom of Figure 2.4; the bundle of aqua-green ground wires lead into the star ground). This would serve as the physical grounding point, so all of the original circuit grounds would lead here instead of directly into the chassis. Since the washer was in contact with the chassis, it was at nearly the same potential. This method directed all of the currents to ground into a communal point, which eliminated different paths to ground crossing each other and creating interference.

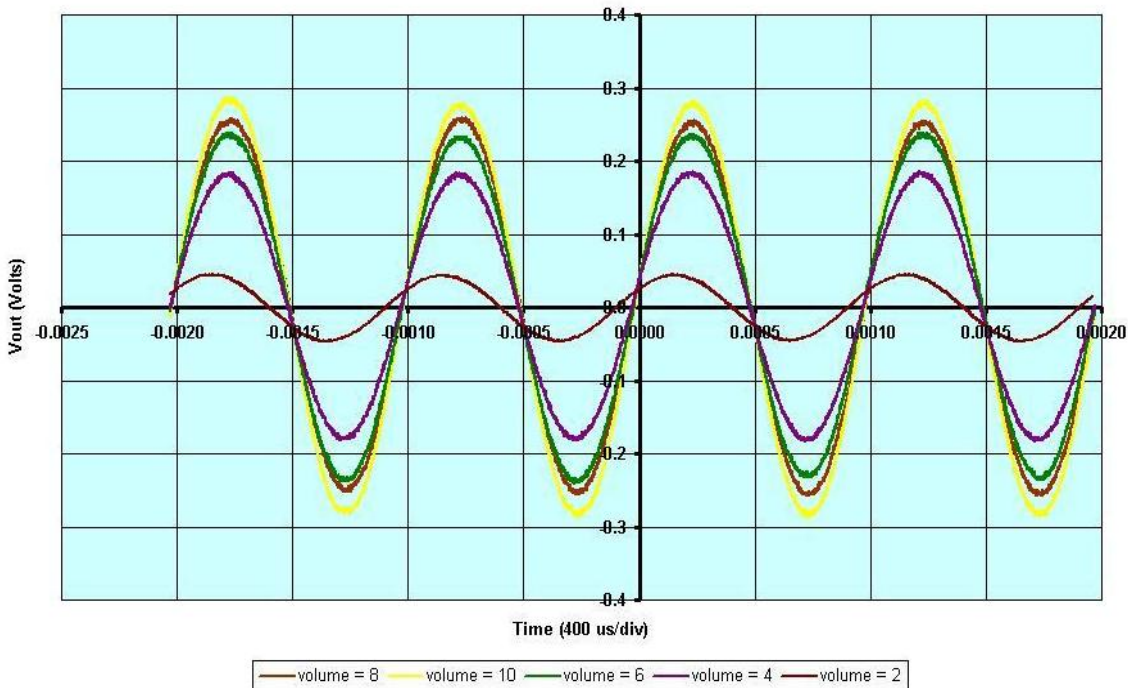
**Fig. 3.1.1** Output voltage on original 5E3 design with varied volume levels using a 10mV, 100kHz sinusoidal input

The first test we conducted compared the signal output of the original 5E3 Deluxe design (with 1<sup>st</sup> preamp stage 12AX7) at various volume levels using a 10 mV input signal (Fig. 3.2.1). We used a 10 mV, 1 KHz input signal because the small signal does not allow the amp to go into cutoff and we can isolate the effect of the volume undistorted. The test was conducted to provide a benchmark for comparison since the output signal is undistorted.

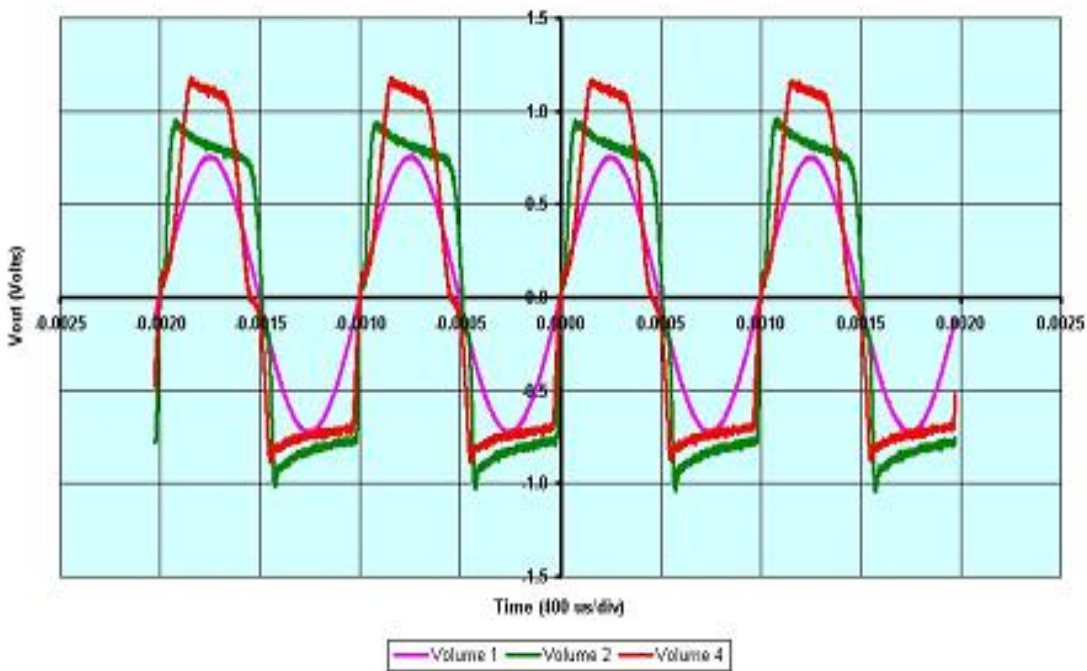
**Fig. 3.1.2** Output voltage on original 5E3 design with varied volume levels using 100mV, 1kHz input sine wave

The original design of the Fender Tweed 5E3 Deluxe (with 1<sup>st</sup> preamp stage 12AX7) began to produce a distorted sound shortly after turning the volume knob past a level of 2. This effect could be easily heard by a discerning listener, but we wanted to quantify the effect of volume level on distortion. Therefore, we input a 100 mV, 1kHz signal into the amplifier and varied the volume level, plotting the output waveforms of the speaker terminal. Figure 3.1.2 suggests that the original design goes into cutoff distortion at a volume level of 2.

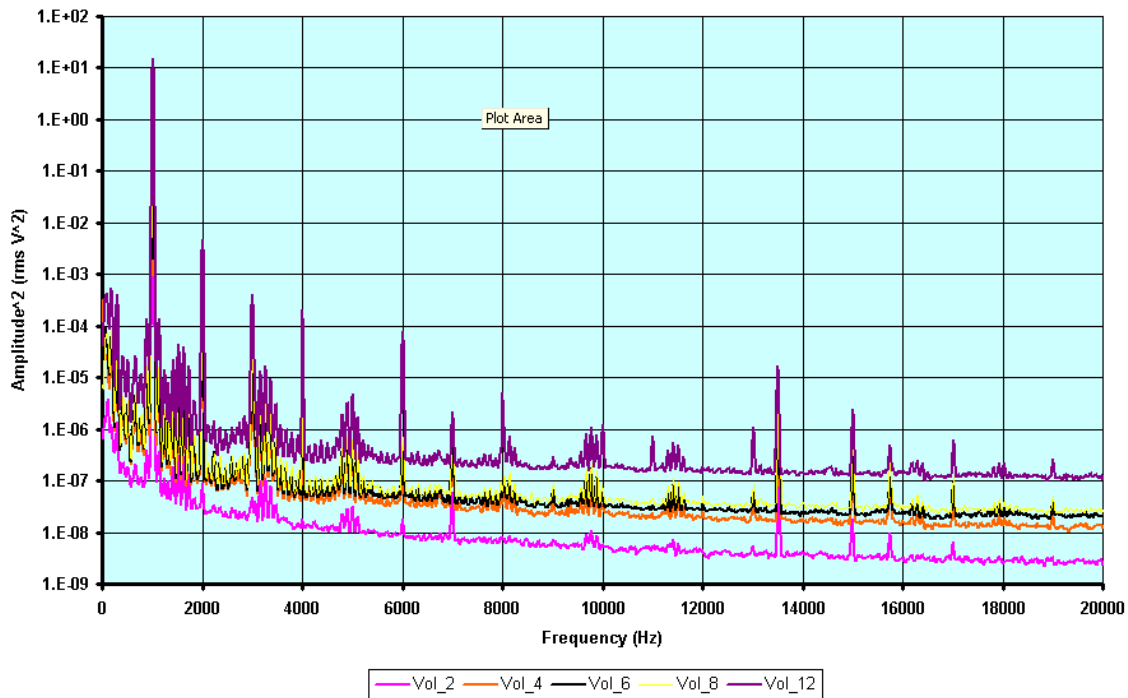
**Fig. 3.2.1** Effect of volume level on frequency spectrum. 10mV 1kHz input sine wave  
Original 5E3 Deluxe with 12AX7 1<sup>st</sup> stage preamp tube

The first test we conducted compared the frequency components of the original design's signal output at various volume levels (Fig. 3.2.1). A 10 mV, 1 kHz signal was input into the amplifier's bright 1 channel and the output from the speaker terminal (with an 8Ω/25W non-inductive dummy load) was input to a HP3562A dynamic signal analyser. Again, we used a 10 mV 1kHz input signal because the small signal did not allow the amp to go into cutoff and we can isolate the effect of the volume undistorted. This test provides a baseline case for comparison since the output signal was undistorted. The graph shows that the amplifier introduces low amplitude higher order harmonics into the input signal at all volume levels, and these harmonics increase in amplitude as the volume level increases. Note also the 60Hz and 60Hz harmonics apparent below which have their own respective peaks, though not as high as the amplifier's fundamental frequency and its own harmonics.

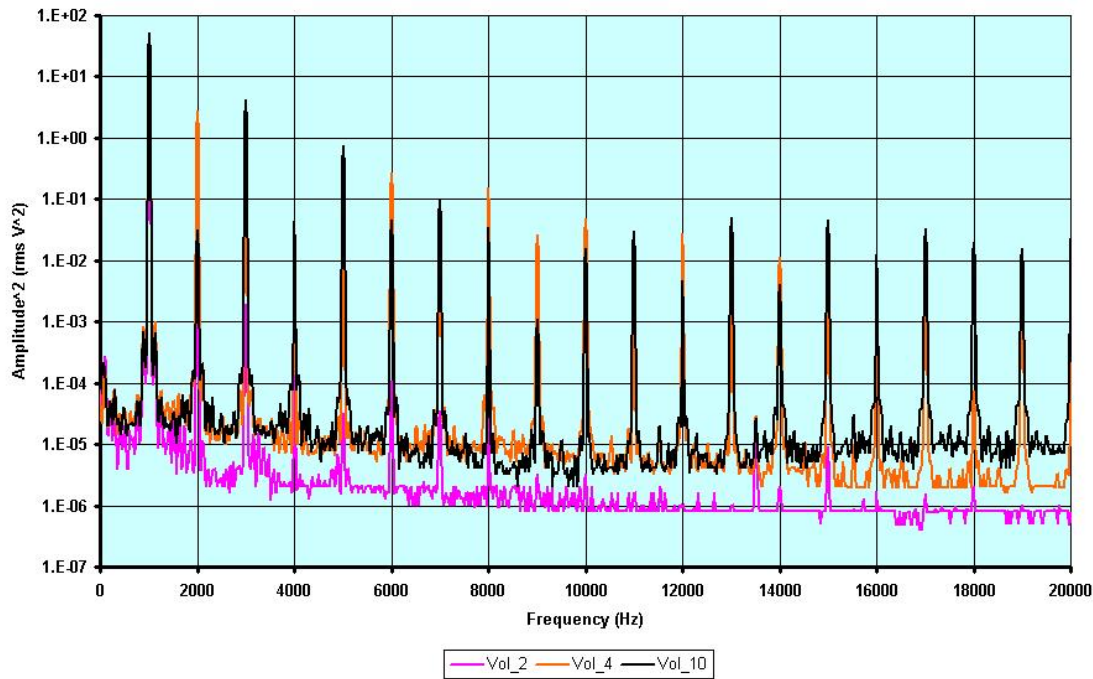
**Fig. 3.2.2** Frequency spectrum at 8Ω dummy load of original 5E3 Deluxe circuit (with 1<sup>st</sup> stage 12AX7 preamp tube) at different volume levels. 100mV 1kHz sine wave input

A 100 mV, 1 kHz signal was input to the amplifier's bright 1 channel and the output from the speaker terminal (with 8Ω/25W non-inductive dummy load) was input to the HP3562A dynamic signal analyzer. Figure 3.2.2 demonstrates the addition of higher order harmonics and overtones at low volume levels. The input voltage of this test was 10 times higher than that of 3.2.1 and the resulting graph shows that the higher order harmonics have much higher amplitudes due to the signal going into cutoff distortion. At a volume level of 2, the amplitudes of the higher order harmonics were relatively low but they increased substantially as the volume increased to a value of 4.

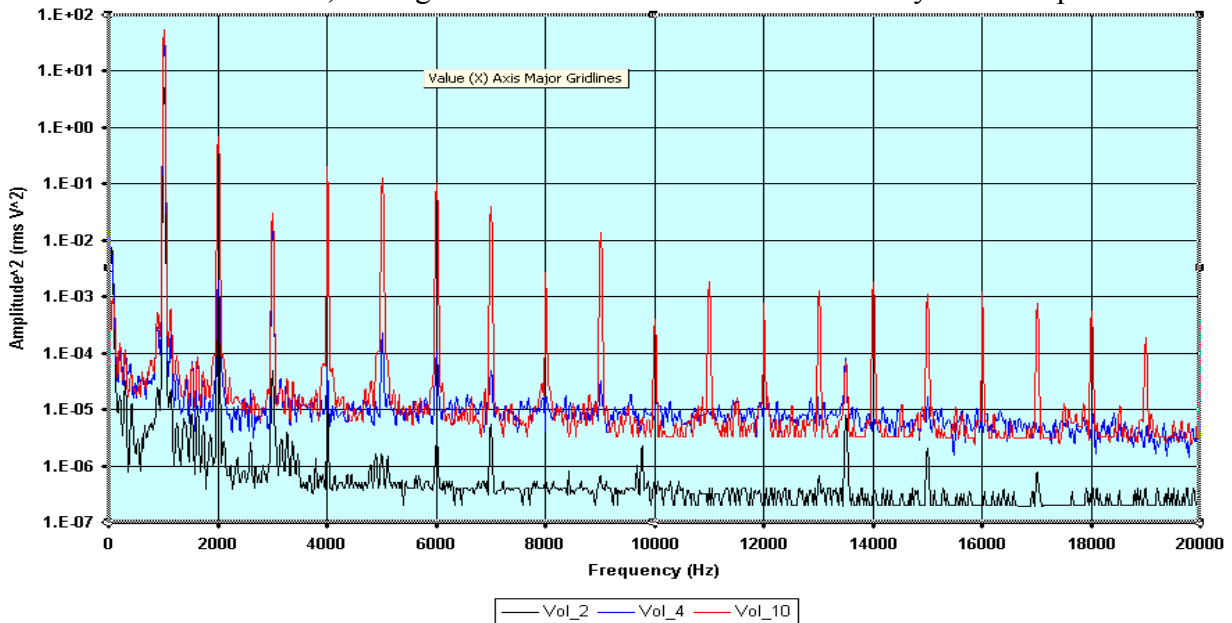
**Fig. 3.2.4** Frequency spectrum of modified 5E3 Deluxe (with 12AX7 1<sup>st</sup> stage preamp) circuit with feedback at various volume levels. No 2<sup>nd</sup> stage cathode bypass capacitor

The addition of the feedback loop to the previously modified 5E3 Deluxe circuit increased the value the volume level could reach before going into cutoff saturation to a value 7. The resulting output signal therefore was smoother at higher volume levels and this is reflected in its frequency spectrum as a decrease in amplitude of the higher harmonics. Figure 3.2.4 verifies this result. It shows that even at volume level of 10, the higher order harmonics have considerably lower amplitudes.

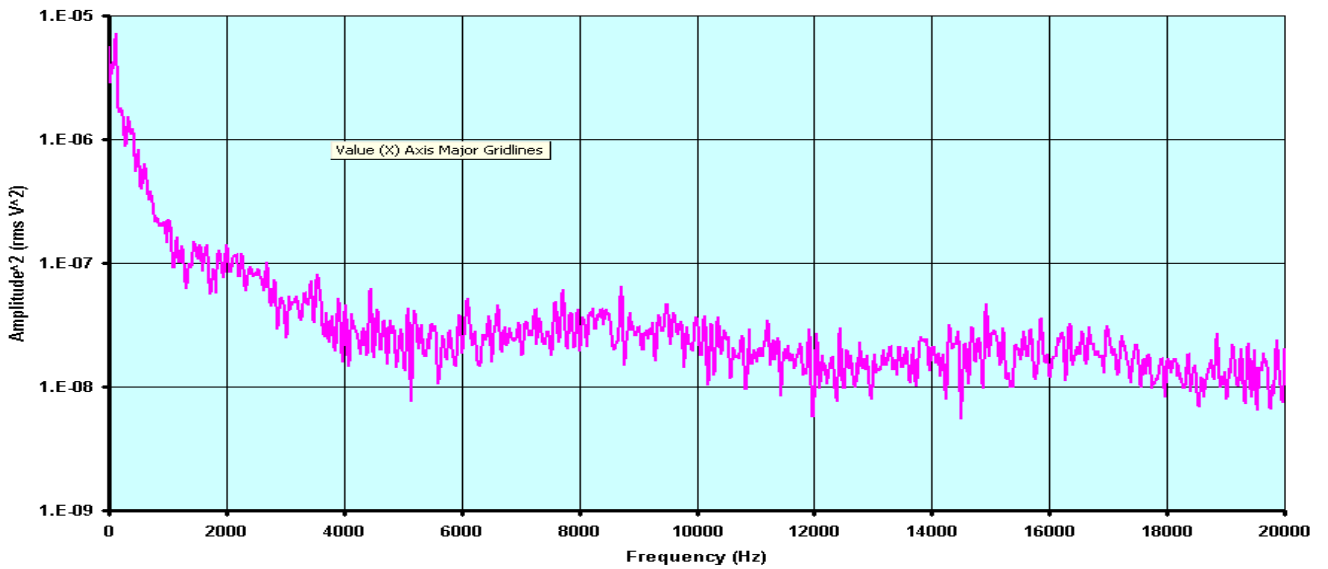
**Fig. 3.3.3** Modified 5E3; Floor noise level in audio range

The range of the test was changed to include the full audio spectrum from 0 to 20 KHz. The test shows that the floor noise level with the amplifier on is higher in amplitude at the lower frequencies and decreases to a relatively steady value from 4 kHz to 20 KHz (Fig 3.3.3).

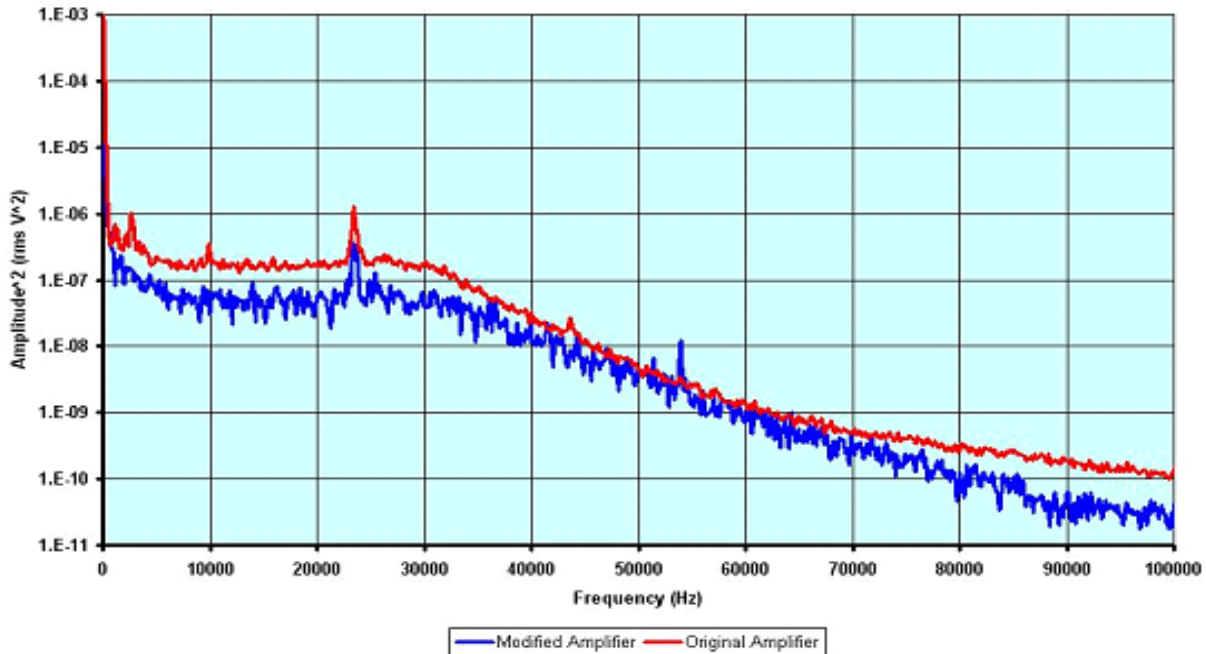
**Fig. 3.3.4** Floor noise comparison, Original vs. Modified Fender 5E3 Tweed Deluxe (no 2<sup>nd</sup> stage cathode bypass capacitor; addition of feedback loop)

We conducted a comparison of the floor noise levels between our modified amplifier and an original Fender Tweed Deluxe (owned by Professor Errede) to show the differences in the overall circuit noise and higher level harmonics associated with 60 Hz hum and outside interference. The original amplifier emitted loud hum due to poor grounding practices and wiring techniques. This is a problem that we addressed in the fabrication of the amplifier and is verified by a comparison of the floor noise levels (Fig 3.3.4). The differences in amplitude at the various frequencies were converted to percentages and plotted (Fig. 3.3.5). This shows that the reduction in floor noise level and associated hum is about 75 % within the audio range and the overall difference is 55 %.

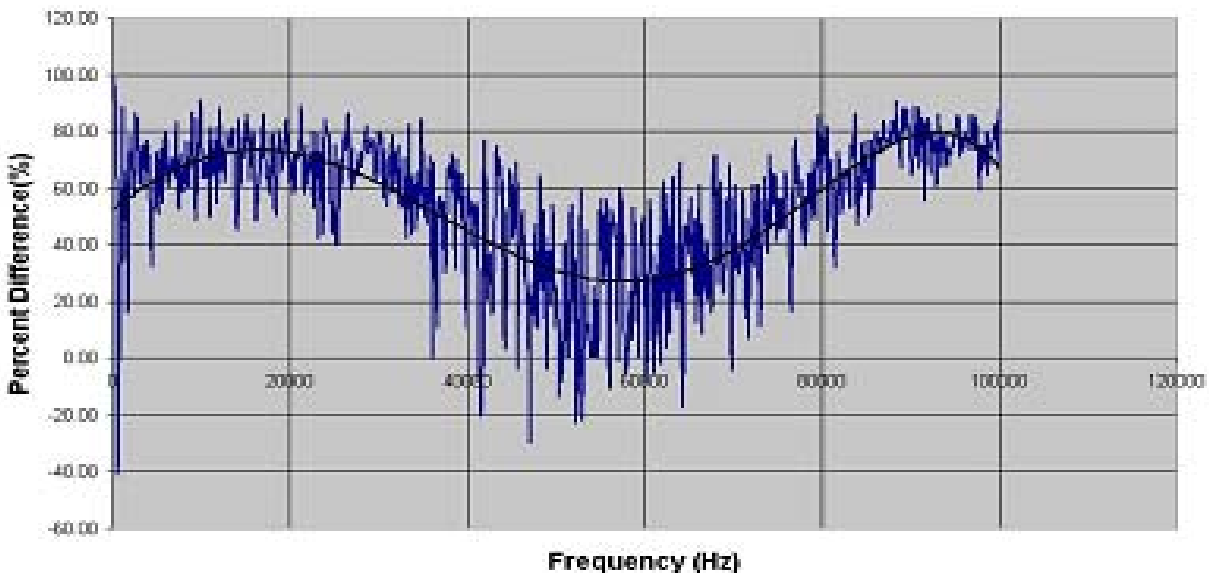
**Fig. 3.3.5** Floor noise level percentage difference, Original vs. Modified. Fender Tweed Deluxe (no 2<sup>nd</sup> stage cathode bypass capacitor; addition of feedback loop)

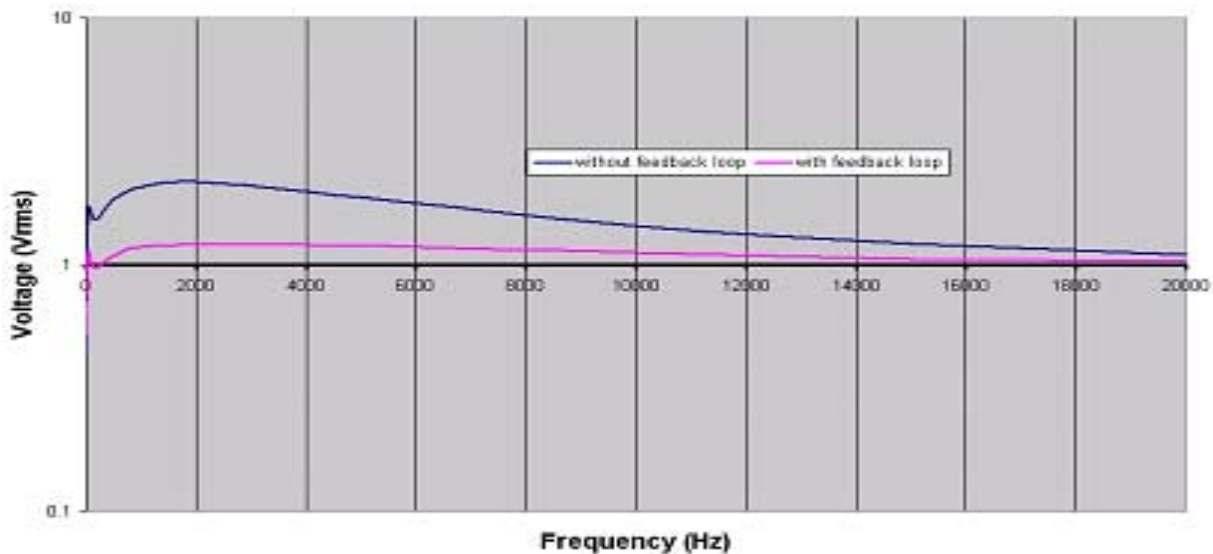
Fig. 3.4.1 Comparative Frequency response plot at mid-tone level.

The frequency response of the original circuit demonstrates that low frequencies are amplified more than high frequency when the tone level is at the midpoint. We wanted to flatten the frequency response so that all frequencies are amplified the same throughout the audio range when the tone level is at the midpoint. The addition of the feedback loop accomplished this by attenuating low frequencies more to achieve the flat mid-tone response (Table 3.4.1). The amplifier's frequency response was calculated by taking rms voltage measurements at the speaker terminal for varying frequencies and plotting the waveform (Fig. 3.4.1).
